**TEST REPORT**  
for  
**ASTM E330 Uniform Static Load Test and ASTM E72 Racking Test Method**

***Autoclaved Aerated Concrete Non-load-bearing Exterior Wall Panels with Wood Frame and Steel Frame***

**Report No.:** AMAB042222-31(R0)  
**Test Date(s):** 06/21/2022 - 09/20/2022  
**Report Date:** 11/17/2022  
88 pages

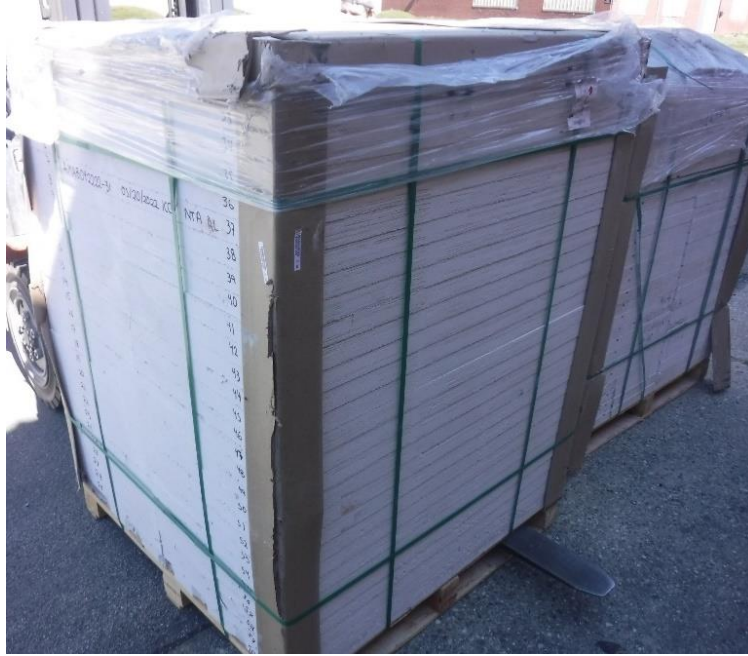
**Photo No. 1  
Received Materials in Shipment 1**

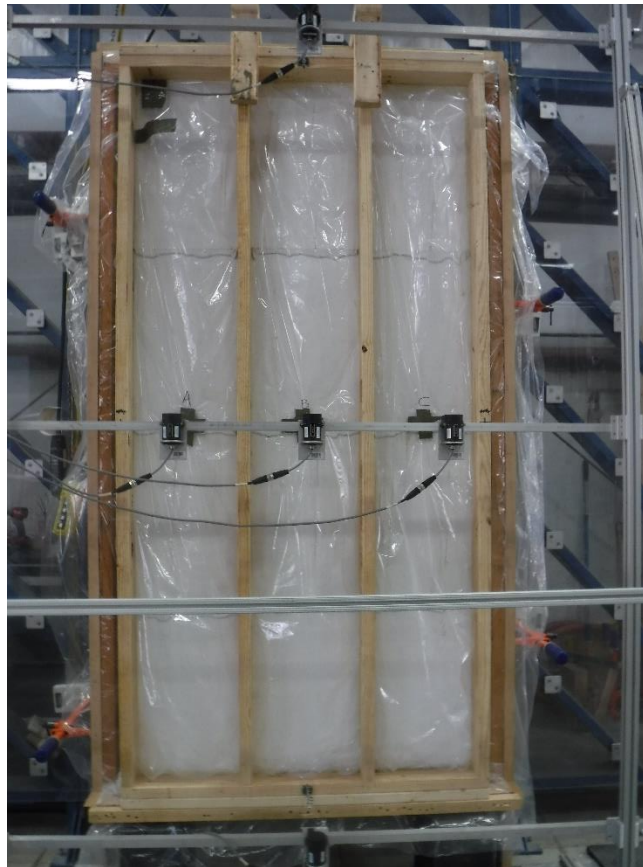
**Photo No. 4**  
**Uniform Static Load Test Setup (Wood Frame/Negative Pressure Direction)**

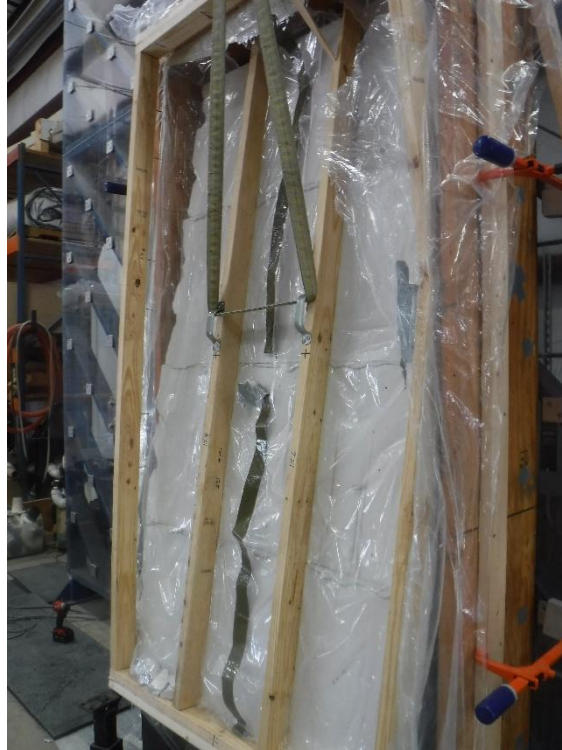
**Photo No. 5**

**Example of Uniform Static Load Failure (Wood Frame/ Negative Pressure Direction)**

Panel Type	Pressure Direction (In-Use)	Specimen Number	Ultimate Pressure (psf)	Failure Mode
Aircrete wall with wood frame	Positive	144585	199	Stud withdrawal of all studs at top of specimen. Cladding breakage mostly at top.
		144586	213	Stud withdrawal at top of specimen, breakage of end stud, crack and crumbling of cladding all around, but mostly at top.
		144587	202	Stud withdrawal at top of specimen, cladding separation from end stud/fasteners, cladding cracking, and breakage throughout.
	Negative	144588	166	Studs all withdrew at bottom plate.
		144589	169	Stud withdrawal at center studs, split stud at edge, face withdrawal top half of panel.
		144590	157	Stud withdrawal on at top of panel, all studs.
Aircrete wall with steel frame	Positive	145652	197	All cladding blew in and broke apart into mostly larger pieces, but also small. Steel stud in center bent slightly and came off the track on the bottom.

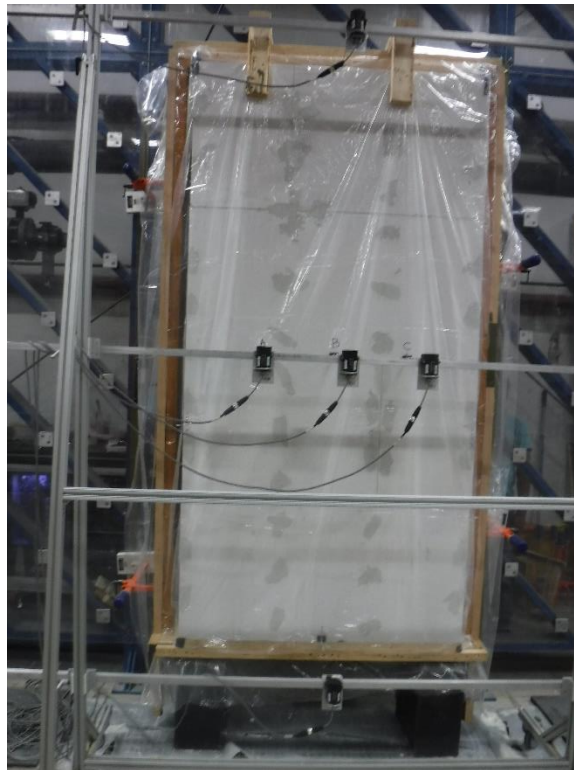
**Photo No. 6**

**Uniform Static Load Test Setup (Wood Frame/Positive Pressure Direction)**

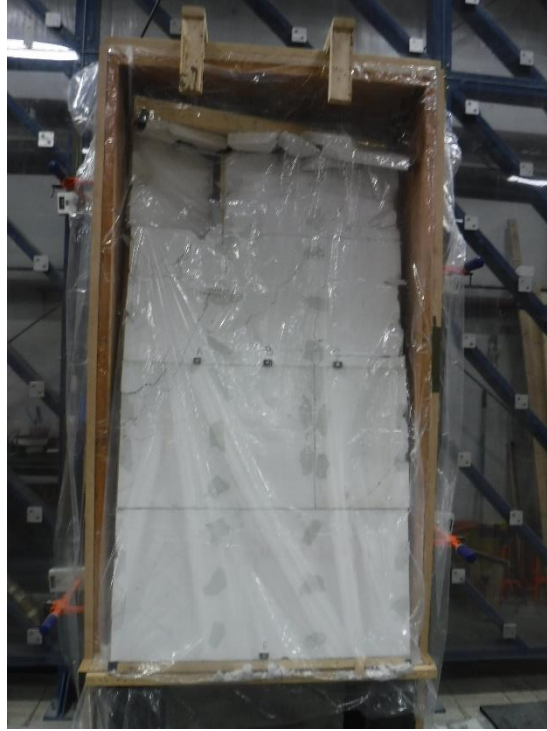
**Photo No. 7**

**Example of Uniform Static Load Failure (Wood Frame/ Positive Pressure Direction)**

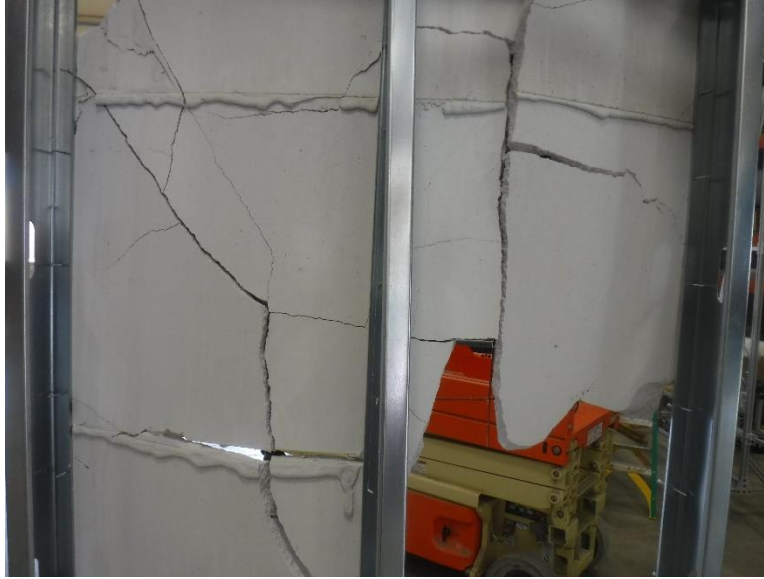
**Photo No. 9**

**Example of Uniform Static Load Failure (Steel Frame/ Positive Pressure Direction)**

145653	204	Fastener withdrawal of interior stud to bottom plate.
		145654	191	All cladding blew in and broke apart into mostly larger pieces, but also small. Steel stud in center came off the track on the bottom.
	Negative	145655	101	Steel studs buckled at center of panel cracking face at center seem and cladding breakage at corner/edge of center piece by fasteners.
		145656	101	Steel studs buckled at center of panel, cracking face at multiple points (Center seem across width, lower center vertical, top corner fork split), and cladding breakage at center fastener. There was a crack/pop sound while running 1 1/4 design pressure.
		145657	102	Steel studs buckled at center of panel cracking face at center seem and smaller cracking on lower cladding panel.

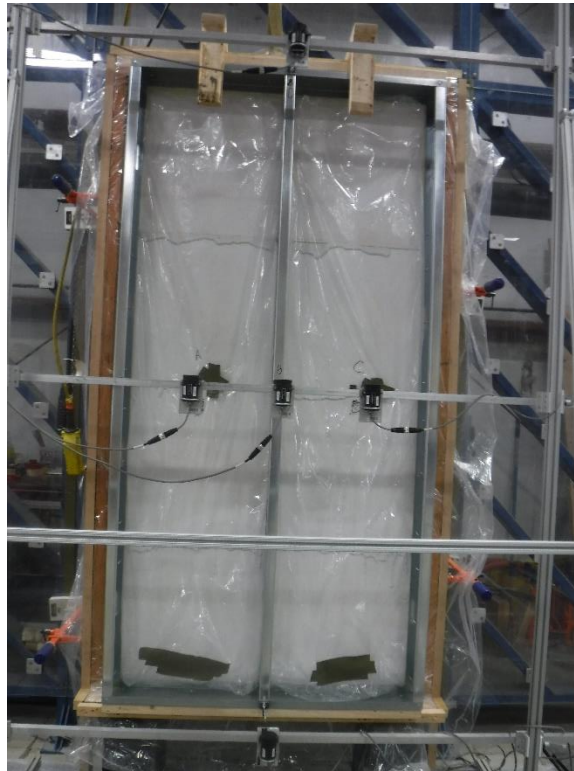
**Photo No. 10**

**Uniform Static Load Test Setup (Steel Frame/Negative Pressure Direction)**

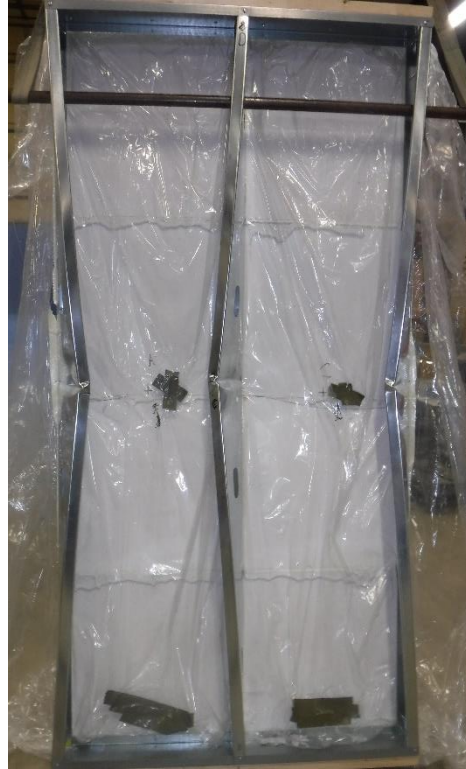
**Photo No. 11**

**Example of Uniform Static Load Failure (Steel Frame/ Negative Pressure Direction)**

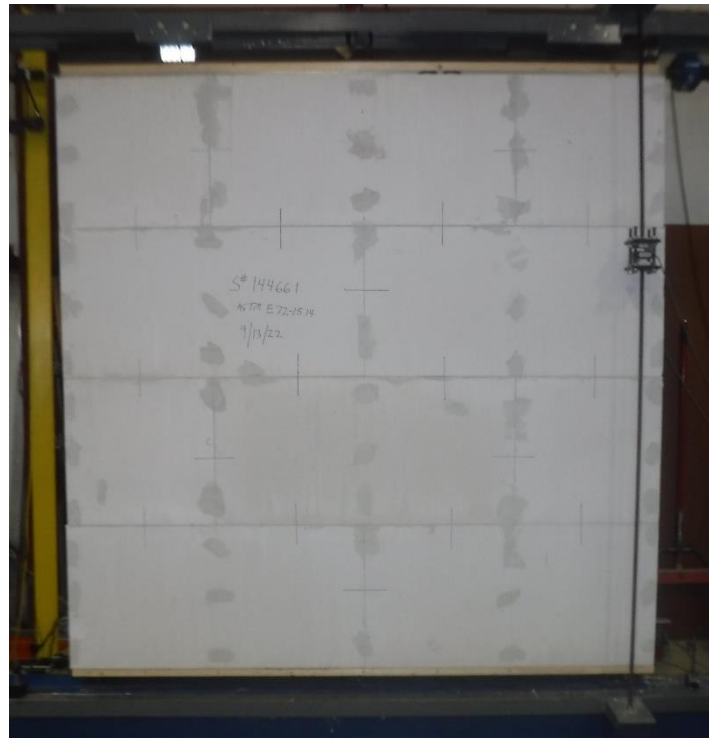
**Photo No. 12**

**Racking Test Setup**

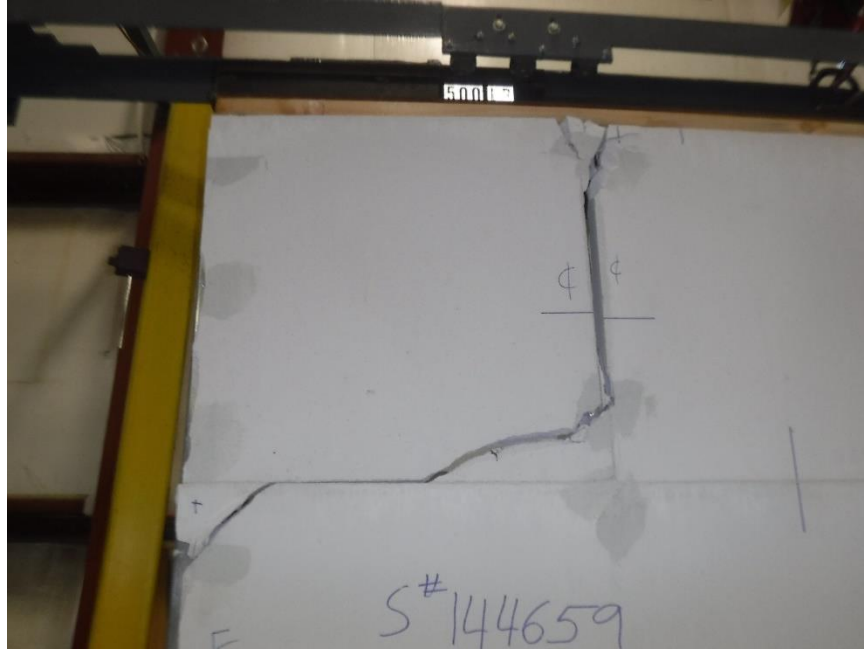
**Photo No. 13**  
**Example 1 of Racking Test Failure (Steel Frame)**

Panel Type (in.)	Specimen Number	Ultimate Load (lbf)	Load at 0.200-in. Deflection (lbf)	Load at 1/8-in. Deflection (lbf)	Failure Mode
Aircrete Wall with Steel Frame	144659	2,616	623	484	Fastener break out at edges of cladding (top 2/3 of non-loading side, bottom 2/3 of loading side), top corner of cladding opposite loading side broke away at joint
	144660	2,736	1094	889	Fastener break out at edges of cladding (top 2/3 of non-loading side, bottom 2/3 of loading side), top corner of cladding opposite loading side broke away at joint
	144661	2,457	429	302	Fastener break out at edges of cladding (top 2/3 of non-loading side, bottom 2/3 of loading side), top corner of cladding opposite loading side broke away at joint
	Average:	2,603	715	558	--
Aircrete Wall with Wood Frame	144582	3,473	1597	1,234	Fastener break out at edges of cladding (top 2/3 of non-loading side, bottom 2/3 of loading side), top corner of cladding opposite loading side broke away at joint. Diagonal cracks from loading corner to opposite corner.

144583	3,386	1208	872	Fastener break out at edges of cladding (top 2/3 of non-loading side, bottom 2/3 of loading side), top corner of cladding opposite loading side broke away at joint. Diagonal cracks from loading corner to opposite corner.
	144584	3,376	1108	822	Fastener break out at edges of cladding (top 2/3 of non-loading side, bottom 2/3 of loading side), top corner of cladding opposite loading side broke away at joint. Diagonal cracks from loading corner to opposite corner.
	Average:	3,412	1305	976	--

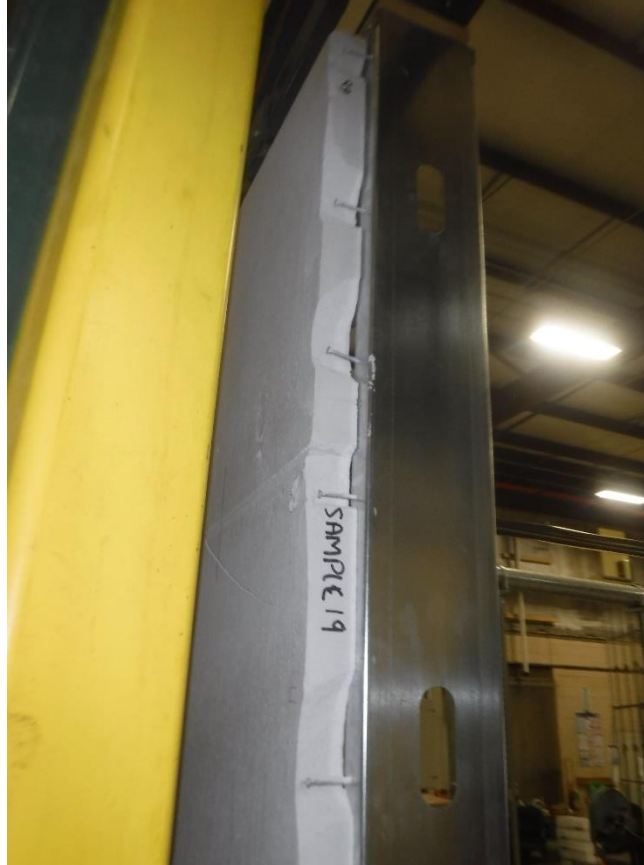
**Photo No. 15**  
**Example 3 of Racking Test Failure (Steel Frame)**

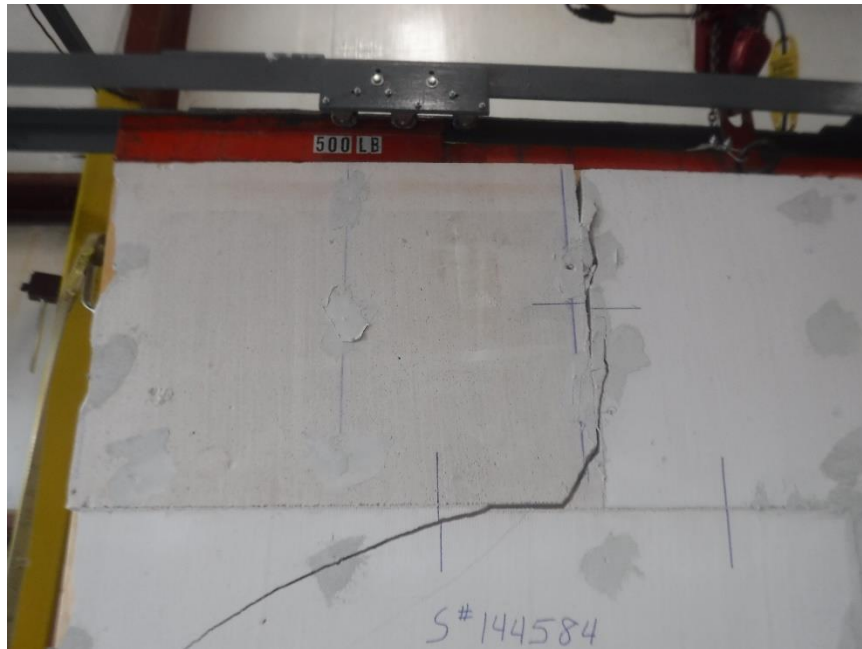
**Photo No. 16**  
**Example 1 of Racking Test Failure (Wood Frame)**

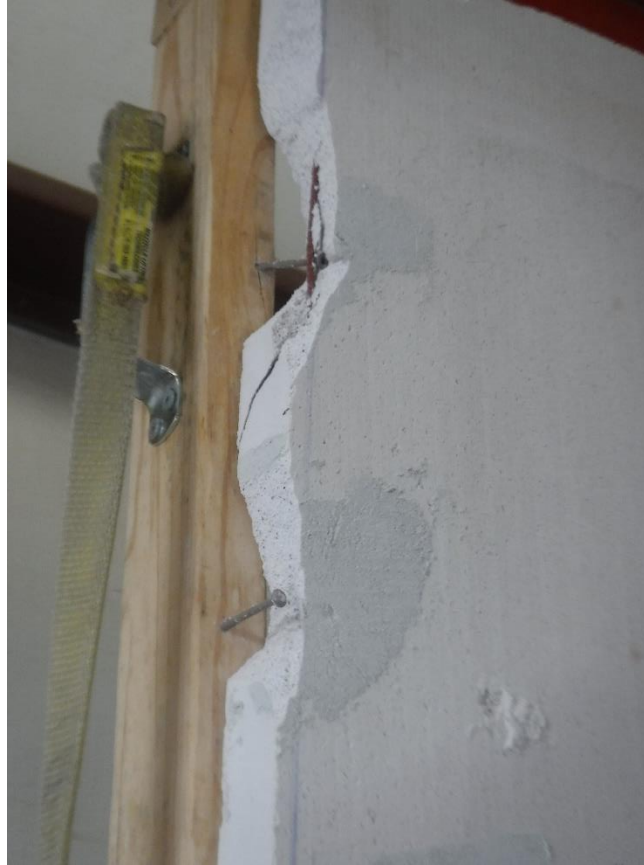
**Photo No. 17**  
**Example 2 of Racking Test Failure (Wood Frame)**

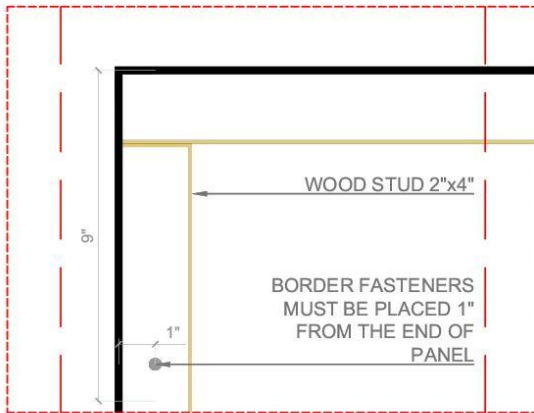
Note - The actual dimensions of the 2x4 wood studs are 1-1/2-inx3-1/2-in. The fasteners were 1-in. away from the center of the wood stud but did not align with the wood stud as shown in detail 02. They are 1/4-in. away from the end of the wood stud.

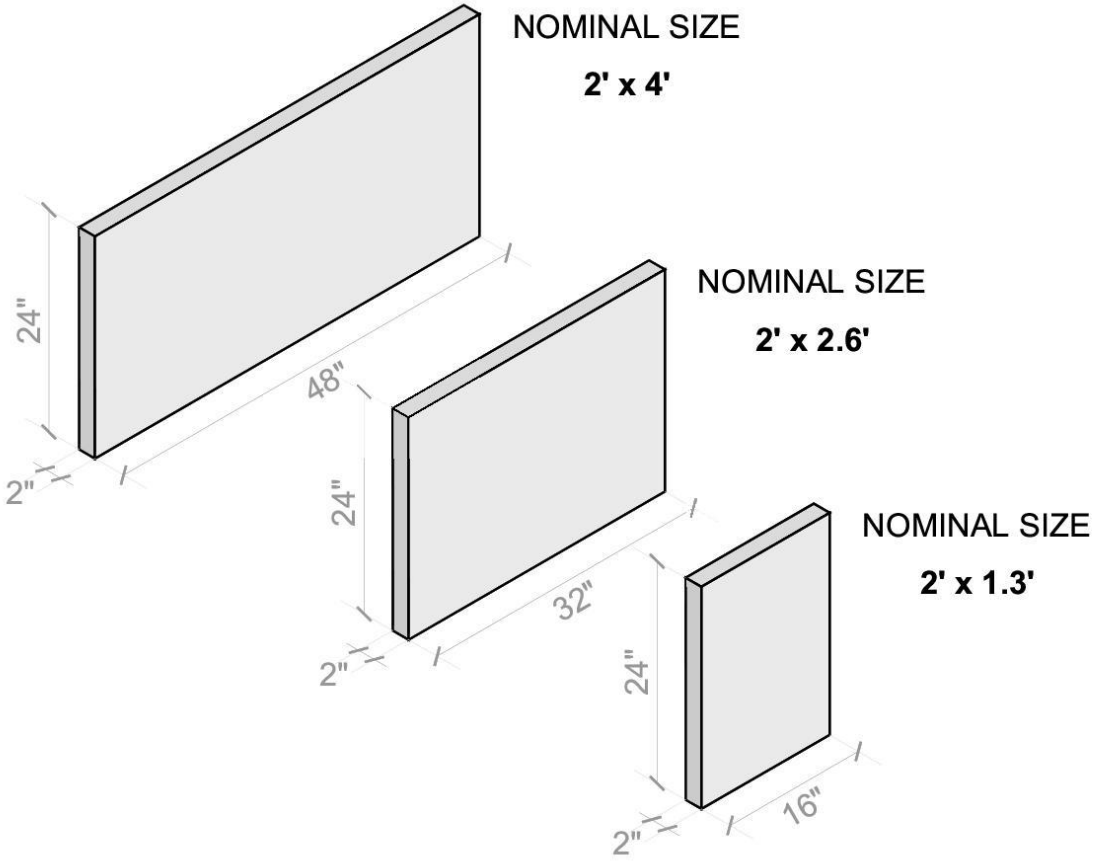
- 1.- LENGTH CAN BE ADJUSTED TO CUSTOMERS NEEDS (EVERY 0.2 INCHES) UP TO 120".
- 2.- THE NOMINAL SIZE OF THE LITECON CLADDING IS 2' X 4', THE ACTUAL SIZE IS 23.62" X 48.03".
- 3.- THE NOMINAL SIZE OF THE LITECON CLADDING IS 2' X 7', THE ACTUAL SIZE IS 23.62" X 80.11".

**Drawing No. 10**  
**Types of Aircrete Cladding**

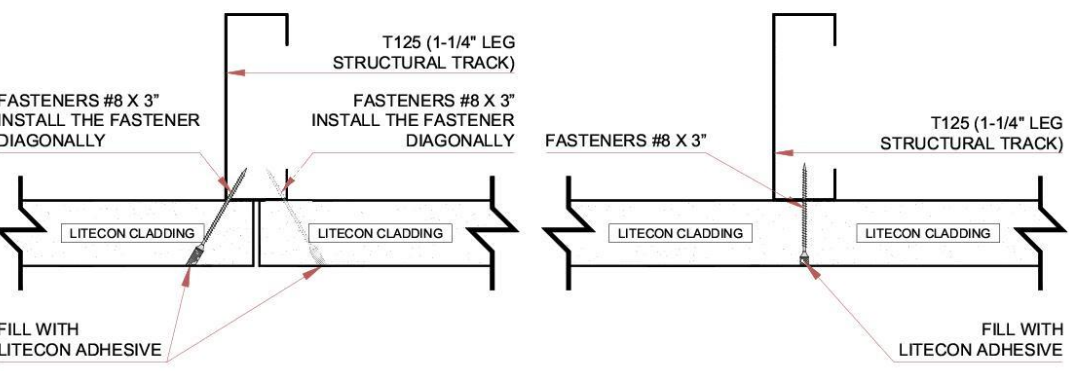
**Drawing No. 19**  
**Additional Installation Details**

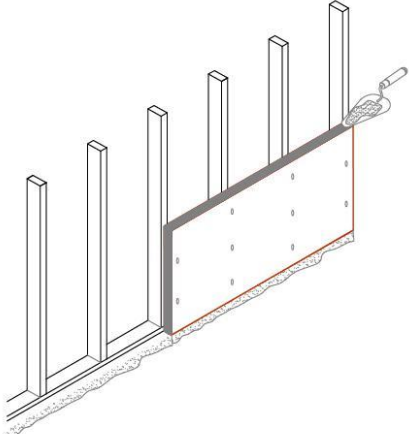
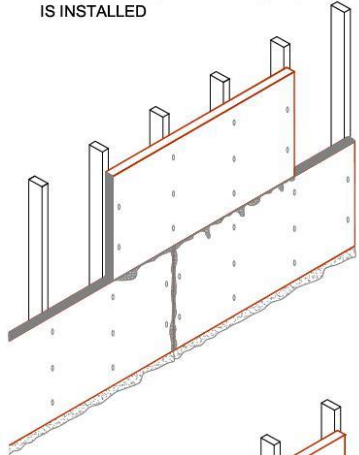
PRODUCT: <b>CLADDING</b>			
AREA: ENGINEERING	ELABORATED: V.G.C.	REVISED:	VERSION: V11 220117	PAGE: 11
<b>WALLS</b> <b>SUBSEQUENT ROWS</b>				
1.- APPLY AIRCRETE ADHESIVE BETWEEN THE MATING FACES		2.- APPLY ENOUGH AIRCRETE ADHESIVE SO THAT IT SPITS OUT ONCE THE LITECON CLADDING IS INSTALLED

3.- AFTER THE LITECON CLADDING IS INSTALLED SMOOTHEN THE AREA WHERE THE ADHESIVE SPAT OUT
